Idaho National Engineering and Environmental Laboratory

SAPHIRE Use at NASA

April 10, 2003

Columbia Accident Investigation

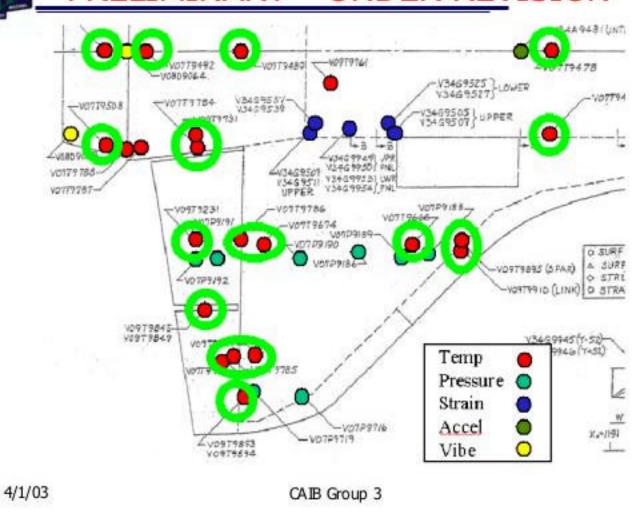
Left Wing Temperature Measurements PRELIMINARY – UNDER REVISION

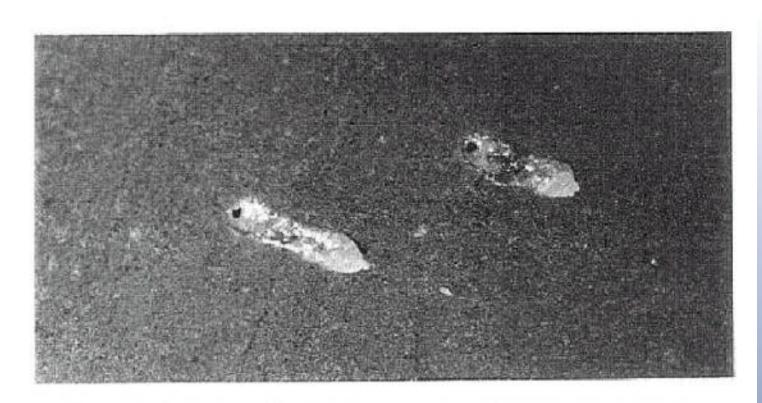
Typical Pinholes - First Discovered on OV-102-12 in 1992

- Pinholes first discovered on OV-102 after 12 flights in 1992
- Pinholes found on all orbiters
- Pinholes increased with flight exposure
 - Total as high as 20 to 40 per panel over time
- Potential root cause of pinholes :
 - Zinc leached out of Rotating Service Structure paint primer
 - Pad Topcoat not refurbished—more primer exposed
 - Rain washes zinc oxide onto Orbiter
 - Zinc combined with Silicon and Oxygen during re-entry to form pinholes

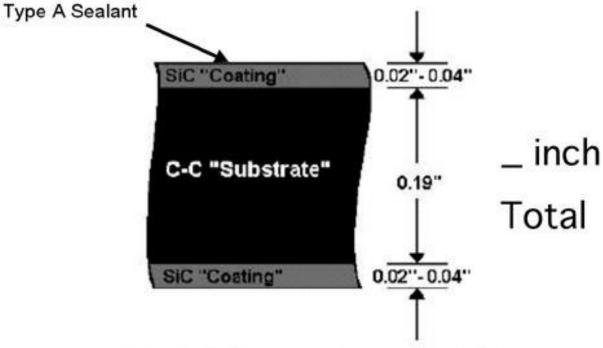
Typical RCC Configuration

Type A Sealant- "Help Protect the Carbon"

Silicon Carbide Coating – "Protect the Carbon"

Carbon-Carbon Substrate – "Carry the Load"
